INTERMOUNTAIN POWER SERVICE CORPORATION

DATE: July 13, 1989  
SUBJECT: Boiler Inspections, November, 1989, Outage  
FILE: 01.12.02 & 43.5800

UNIT 1 BOILER INSPECTION  
SCHEDULED OUTAGE-----NOVEMBER 1989

UNIT 2 BOILER INSPECTION  
SCHEDULED OUTAGE-----NOVEMBER 1989

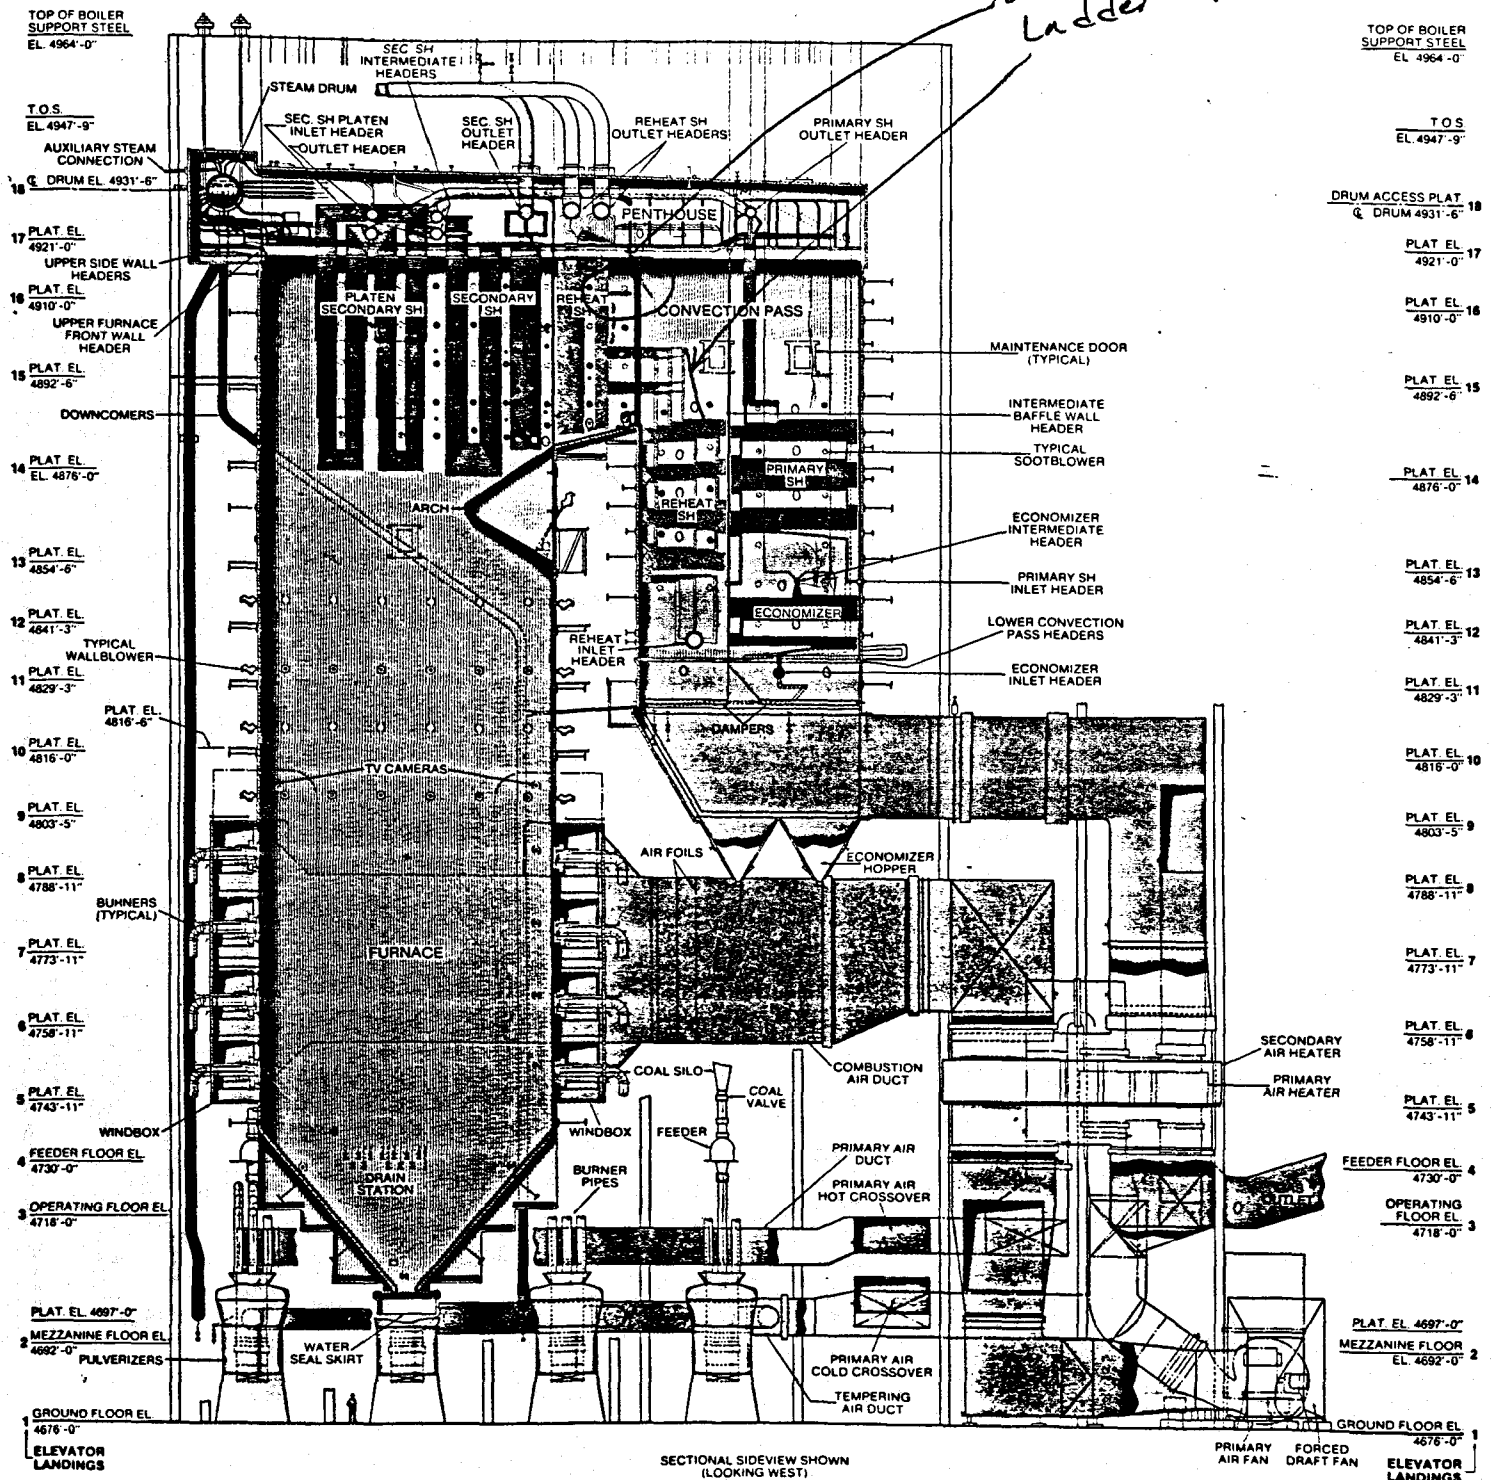
# Unit 2 Reheater Outlet Access.

access.  
ladder + walkway?
